THE CALIFORNIA EARTHQUAKE OF 1906

T h e
California Earthquake
of 1906

Edited by
David Starr Jordan

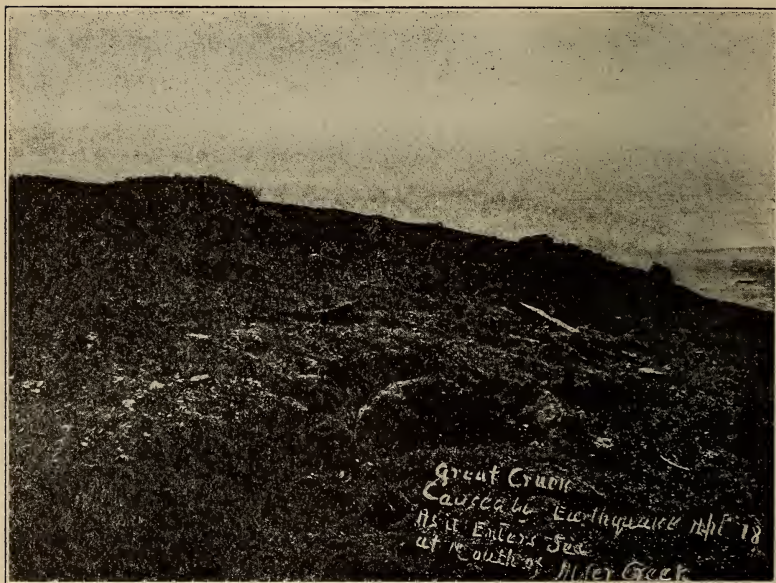
Earthquake Rift, As It Comes up from the Sea at Point Arena, Mendocino County.

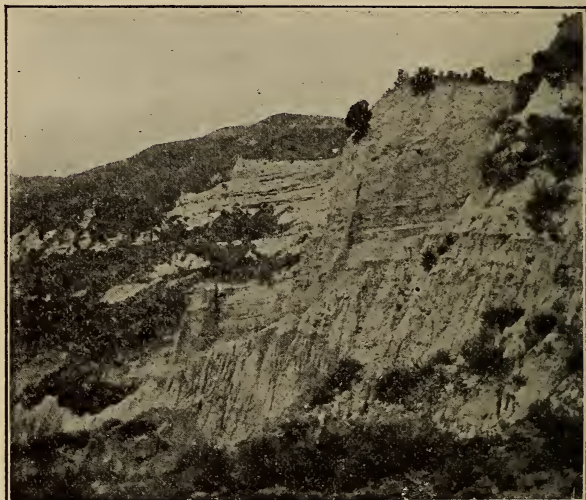
Fissure and Landslip, San Jacinto Valley, 1897.

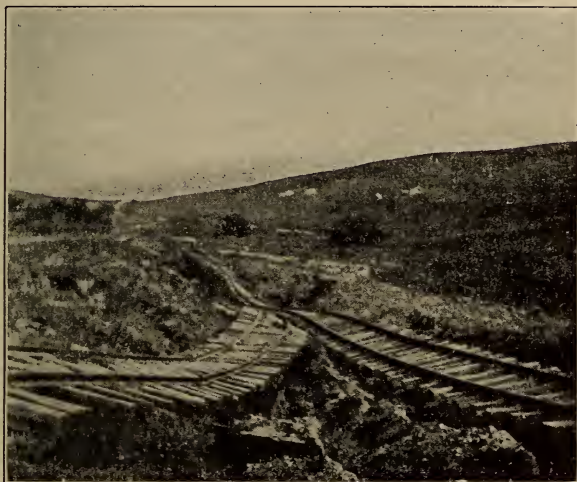
Tomales, Marin County. The North Shore Railroad and the Earthquake Rift.

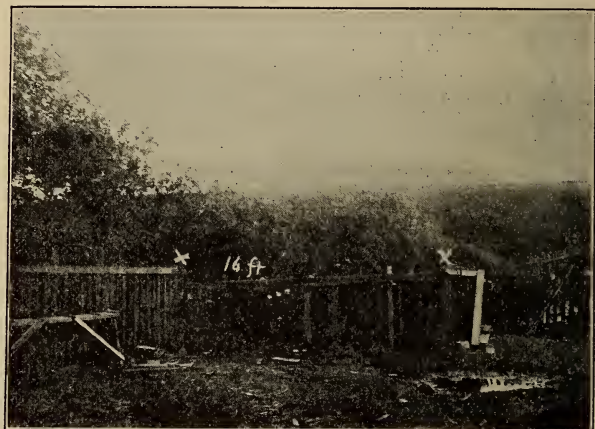
Point Arena. Picket Fence Was in One Continuous Line. Photograph Shows Short Section Put in to Fill up Offset by Land on the West Side.

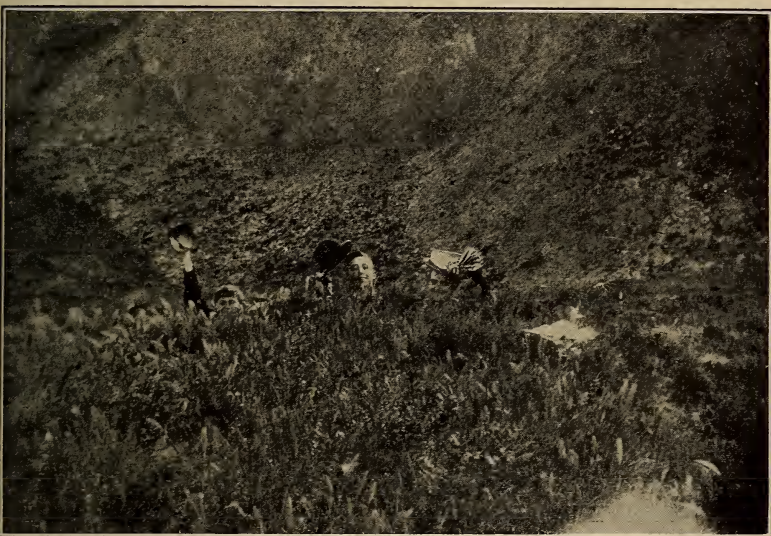
Landslip at Sobrante.

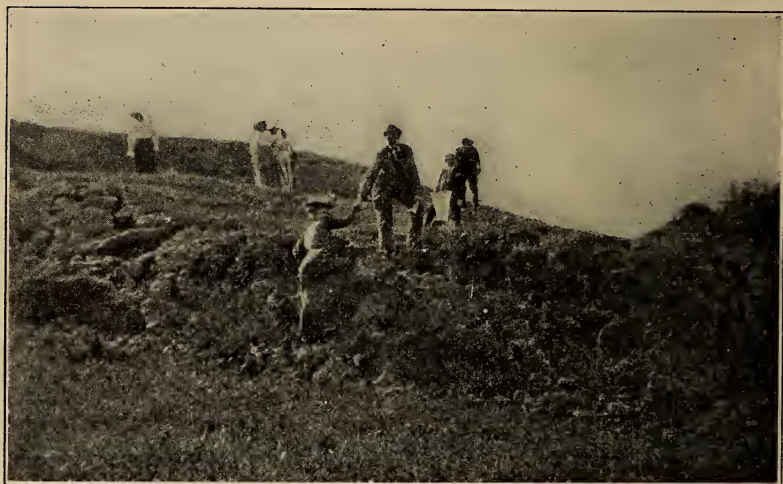
Landslip at Sobrante.

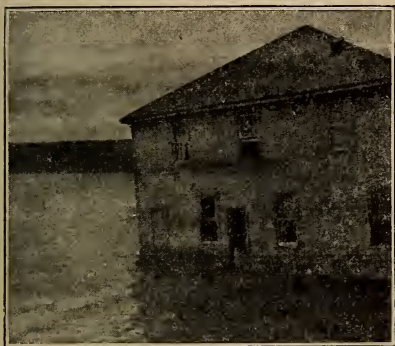
Marshall Hotel, Thrown into Tomales Bay.

At Marshall the humble hotel was thrown bodily—and upright—into the bay, the boarders unharmed; and at aristocratic Inverness, on Tomales Bay, three summer cottages suffered the same fate. A fisherman in the bay reports that the waters of Tomales Bay receded, leaving his boat in the mud.

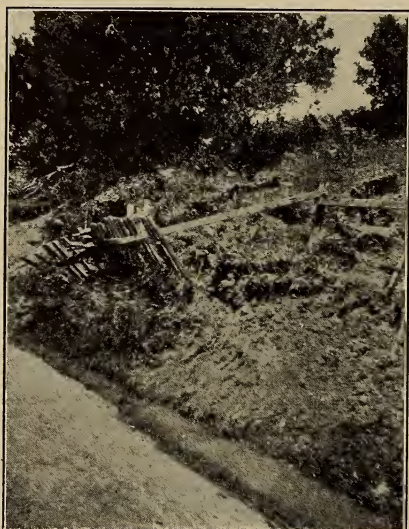
*Earthquake Crack in Country Road from
Olema to Point Reyes.*

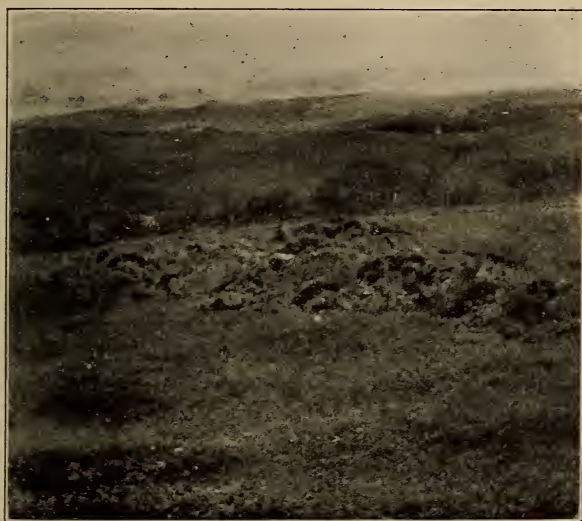
Earthquake Rift, Freeman's Ranch, near Tomales Bay.

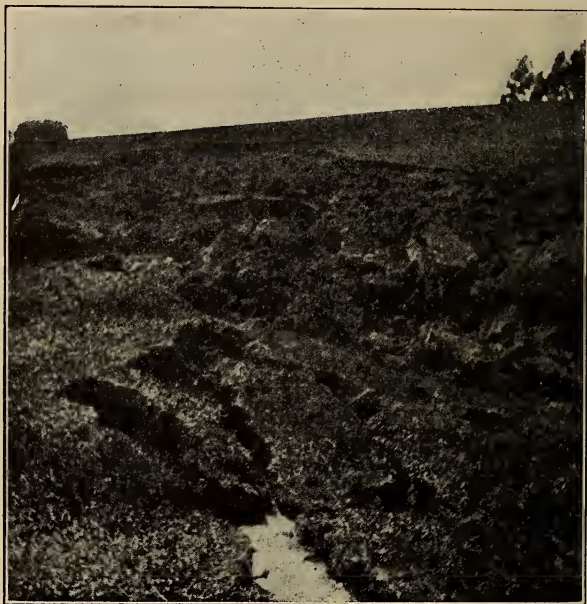
Earthquake Rift, Freeman's Ranch.

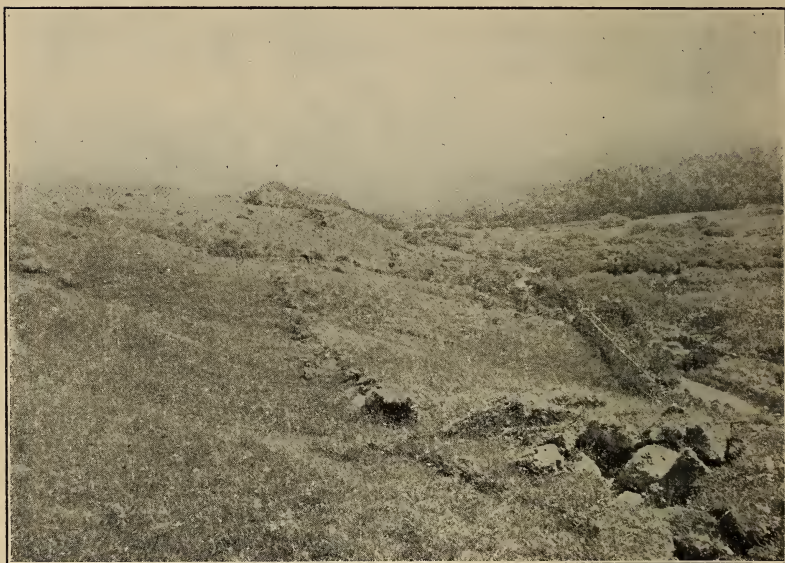
Earthquake Rift, Olema.

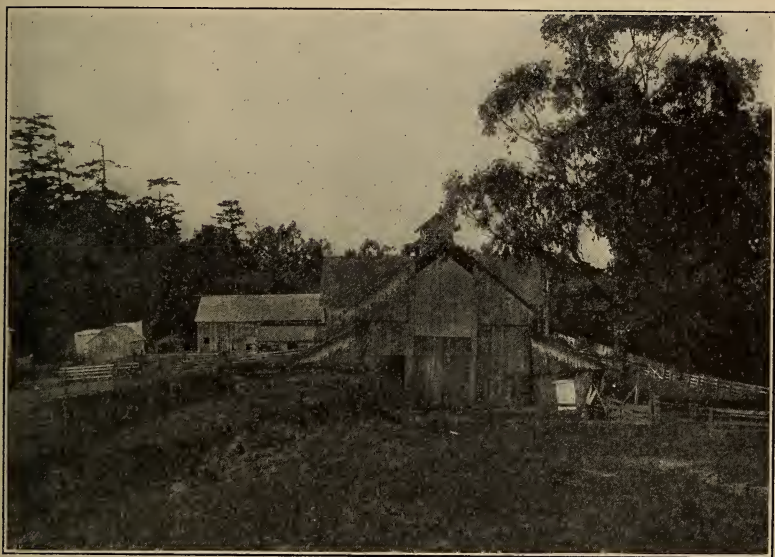
Skinner's Ranch is a large dairy near Olema. The house stands near the road, a dairy house some thirty feet to the south of it, and a large barn with cowyard just behind that. A row of large cypress trees stood just before the house on the roadside, between them and the house a little rose garden, to the south of these, opposite and partly behind the dairy, a group or row of large eucalyptus trees. The earthquake rift passed directly in front of the house, between the buildings and the road. All that stood to the westward of the crack was violently jerked to the north a distance of sixteen feet seven inches, or it may be that the east side moved an equal distance to the south. If Mr. Skinner had chanced to look at the right instant he would have seen the whole row of cypress trees file past his window to take their station in front of the dairy, taking the rose garden with them. A few raspberry bushes came from farther north to take, partly, the place of the roses. The eucalyptus trees in front of the dairy moved on to a position opposite the barn, and one detached from the others and to the westward of the crack was left near the head of the line instead of at its foot. The crack passes obliquely under the barn, entering it at the northwest corner and leaving it at the middle of its pos-

terior or southwest side. The barn remained intact, thanks to its weak foundation, for the east side pulled loose from the ground, and the barn went northward with the west side. Sixteen and

one half feet of its former foundation at the southeastern corner is exposed. A driveway under the barn is divided in the middle. You pass in on the east side, the western half is sixteen and one half feet to the north of the entrance and completely blocked in the middle. Under each of the east windows of the barn stood a pile of manure. Each pile

is intact, sixteen and one half feet south of the window to which it belongs. The people at the ranch were milking at the time of the shock. Each man and cow was thrown to the ground and it took two

hours to get the frightened cattle back into the 'corral.' The stone steps to the basement of the dairy, on the east side of the crack, now stand sixteen feet seven inches to the southward of the door to which they led. About Skinner's, line fences and water pipes crossing the fault were broken, a break of sixteen and one half feet being left

Skinner's Ranch, Olema.

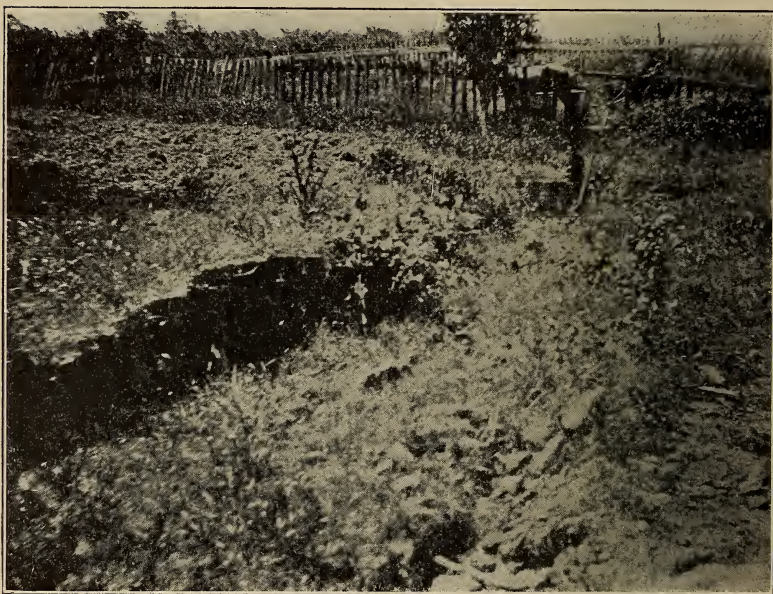
Earthquake Rift, Morrill's Ranch, Skylands, Santa Cruz County.

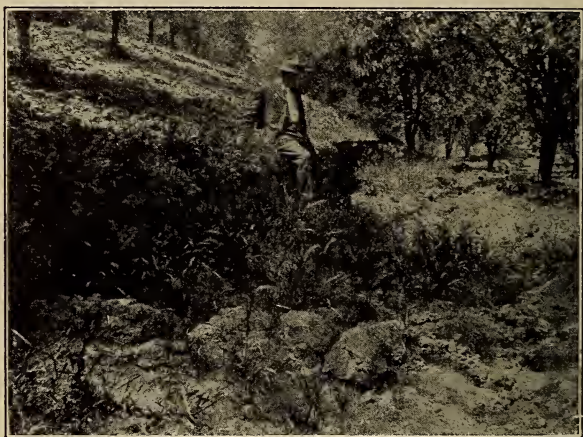
Earthquake Rift, Morrill's Orchard, Santa Cruz County.

The earthquake ripped its way through the orchard, shifting the rows of trees six to eight feet and treating roads and fences in the same reckless fashion. The large hospitable Morrill farmhouse stood partly over the track and was split in two and utterly ruined. Farther on at Skylands, on the ridge of the mountains, Fern Gulch was filled with wreckage; redwood trees four and five feet through, two or three hundred years old, were snapped off like

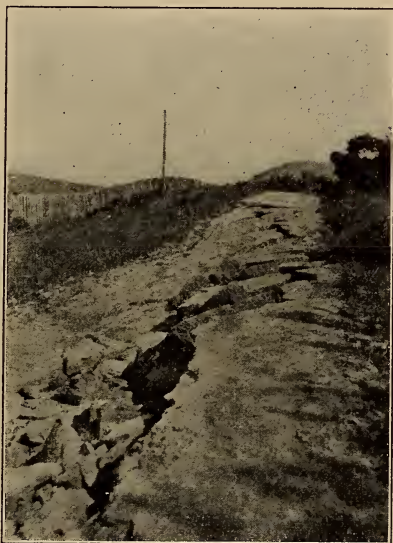
Inverness Road, near Olema, Marin County.

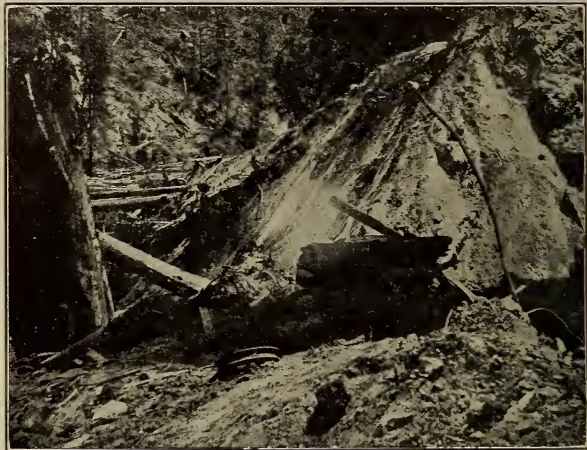
whip-lashes. The rift crossed Hinckley's Gulch at right angles. This is a narrow gorge about a hundred feet deep, in which stood the large Loma Prieta sawmill. The gorge was filled by landslips thrown from both sides. The mill was completely buried, with nine mill hands, and a redwood tree over a hundred feet high was set erect and unhurt over the place where the mill stood. The bodies of six men were recovered. One of these, the foreman, was found erect, smothered in mud, but standing with extended arms and limbs in the act of running from the mill. With him, equally erect and in the act of running was the body of a Siberian mastiff. Their position marked the meeting point of the two walls of the cañon. The crack went on across the hills, always in the same direction, southeast by south, till it came to the Chittenden Ranch in the Pájaro Valley. Here it tore off the hillside,

Wreck of Loma Prieta Sawmill, Hinckley's Gulch, Santa Cruz County.

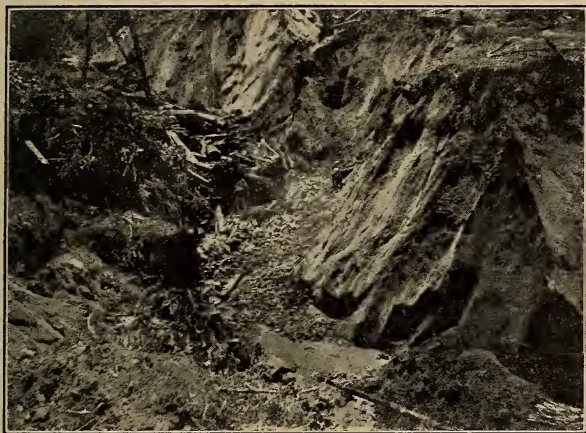
Site of Loma Prieta Sawmill, Covered to the Depth of 125 Feet.

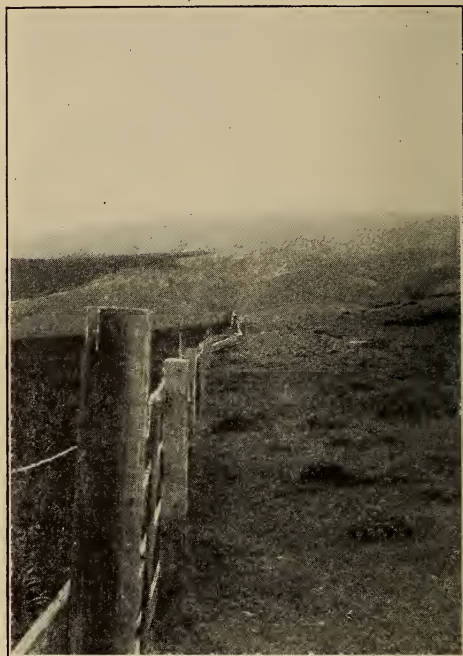
FIG. 6—Fence near the North End of San Andreas Reservoir, San Francisco Peninsula, Offset Seven Feet at the Line of Fault.

compensating places the pipe was telescoped by similar amounts. Fig. 34 shows a break in this pipe line near the up-stream end of San Andreas Lake. The pipe at this point was pulled apart $53\frac{1}{2}$ inches. A property fence, Fig. 6, which crossed

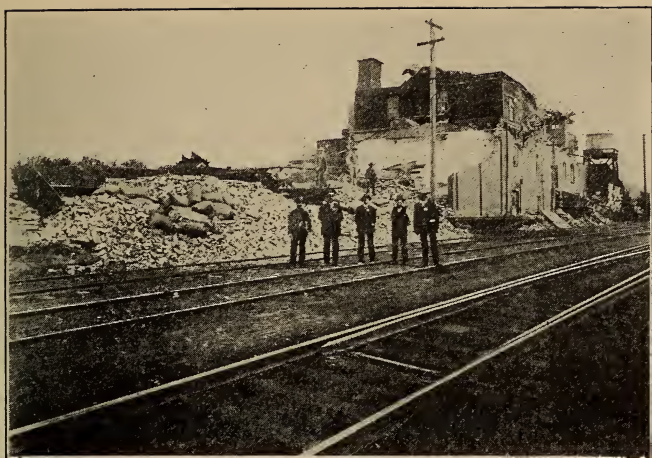
How then should the general destruction be explained? The brick buildings of Santa Rosa were carelessly constructed. Lime mortar was almost invariably used with bad brick bond. The sand of the lime mortar used was what is locally known as "drift" sand, containing, according to a local engineer, practically fifty per cent of loam. When we remember that it has been too common a custom in California to lay brick for small structures without sufficiently wetting them, in fact almost dry, what else should be expected, especially when we further observe a most inadequate anchoring of the floor and roof frames to the outer walls, and a usual absence of necessary cross walls or frames. Besides brick buildings are not capable of withstanding heavy earthquake vibration. It is a fault of design more than of workmanship. Upon this

FIG. 7—Santa Rosa Flour Mill. A Typical Brick Structure with Wooden Interior, Three Stories in Height; the Major Portion Completely Collapsed.

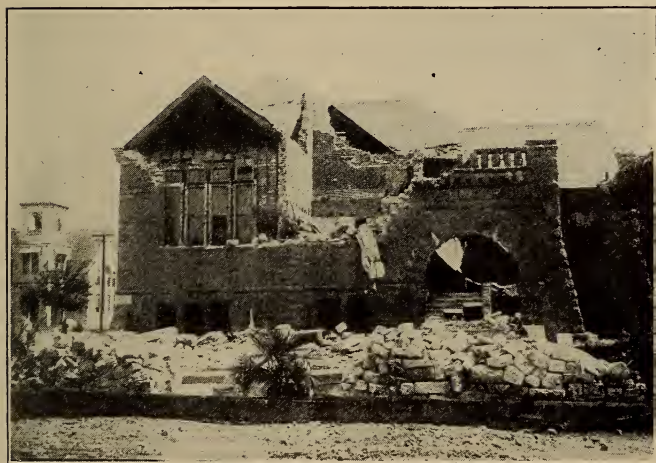
FIG. 8—Carnegie Library, Santa Rosa. A Typical Brick Building with Wooden Interior Framing; the Outer Walls Faced with Cut Stone. Buildings of This Type of Construction Invariably Were Shattered near the Roof Lines. The Picture Is Representative of the Behavior of Stone-faced Buildings with Inadequate Wood Framing.

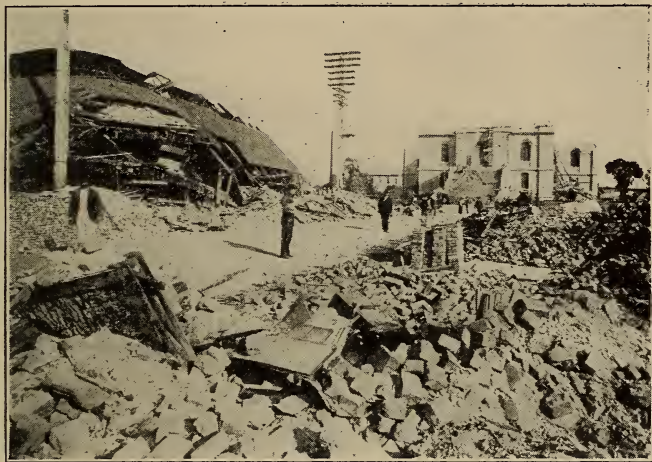
FIG. 9—A Scene in Santa Rosa Photographed Shortly after the Earthquake and Fire. The View Shows the Corner of Fourth and Mendocino Streets. The Ruins of the Court-House face Mendocino Street. On the Left in the Picture Is Seen the Collapsed Keegan-Brush Building, a Two-Story Brick and Stone Structure, Devoted to General Store Purposes. This Building Did Not Burn, and Ninety Per Cent of the Stock Was Saved. On the Right Side of Mendocino Street the Fire Destroyed Everything. In This Respect the Picture Is Instructive in That It Shows the Difference in the Destruction by Earthquake and Fire.

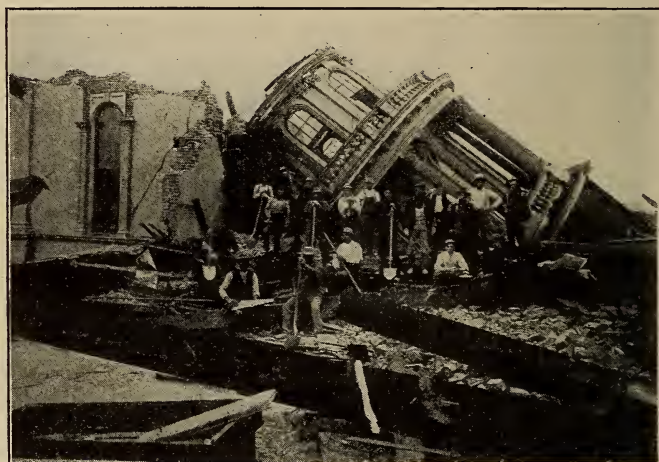
FIG. 10—*The Collapsed Court-House Dome, Santa Rosa. The View Is Taken with the Camera on the Second-Story Roof; See Fig. 9. The Court-House Consisted of Three Stories of Brick, the Third Story Smaller in Plan Than the Other Two. The Third Story Supported the Wooden Dome.*

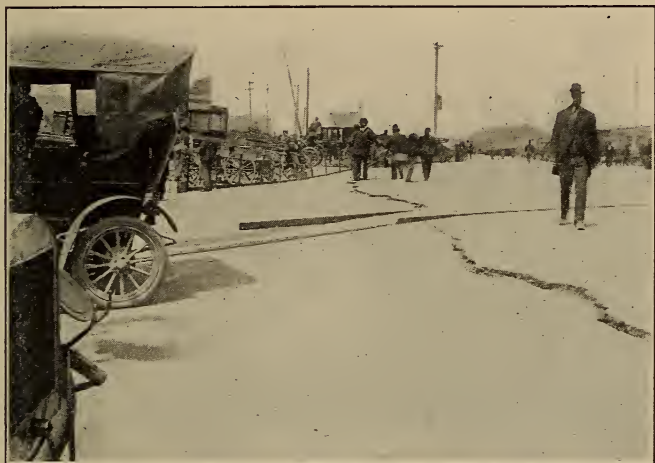
FIG. 11—Street Surface in Front of the Ferry Tower, Showing Undulations and Cracks in the Asphalt Pavement.

Great distortion of the surface was best observed in the streets, and was found on the filled areas and in some places, on the sand dunes. The best localities for observation were:—(1), Market Street near the Ferry Building, Fig. 11; (2), the water front on both sides of the Ferry Building, Fig. 12; (3),

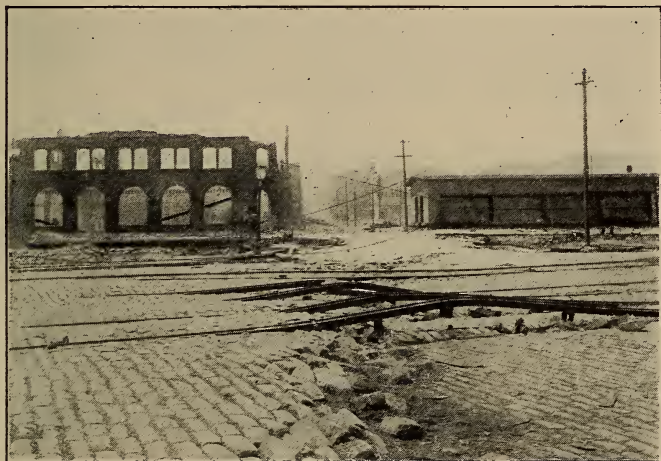
It was in these areas that the sewers and water pipes of the gridiron system were so generally crushed and broken. Even had the main conduits survived, water could not have reached the hy-

drants in the lower Mission District. The brick sewers were uniformly helpless to resist destruction in these regions and the cast iron water and gas pipes fared no better. I believe reinforced concrete sewers in these districts would have shown

*FIG. 12—Rupture of Car Tracks and Pavement on East Street,
Corner of Pacific Street.*

much greater resisting qualities, but I am convinced that even such material could not withstand earthquake stresses on the dividing line between made and filled ground. At such points flexible joints might have helped the sewer and water pipes, but it is difficult to conceive of a practical means for procuring flexibility at any given

around it, and those that must traverse filled areas should be of riveted steel or wrought iron with flexible joints at intervals. Greater probability of resistance to rupture might be further insured by encasing pipes traversing the most treacherous ground in tunnels of reinforced concrete with suitable clearance between the pipe and the tunnel

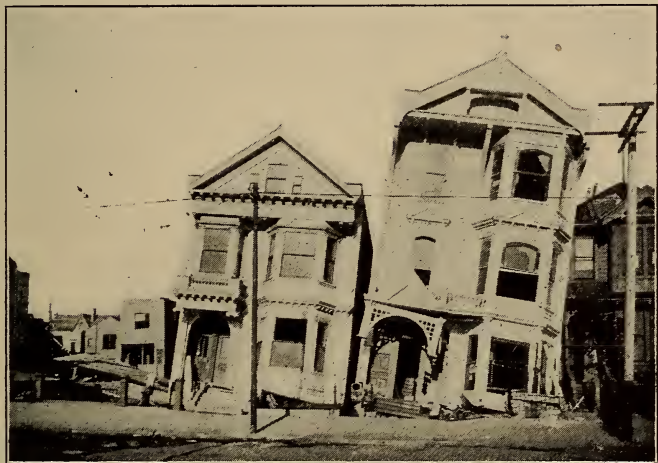
FIG. 14—Collapsed Frame Houses on Howard Street, between 17th and 18th Streets. The One on the Left Is Completely Razed. At This Place the Earth Movements Were Especially Severe, and Even Good Construction Would Have Suffered.

Many frame buildings collapsed on the filled ground, Fig. 14; and an unreasonably large number on the more substantial areas of the city. Some of the destruction in the made land district was unavoidable, but much of the general collapse of frame houses was due to improper underpinning in the foundations. Such houses virtually stood on stilts; consult Figs. 15 and 16. Moreover, the cheaper frame buildings were provided with carelessly constructed brick chimneys built with weak lime mortar; naturally the brick work cracked to pieces. It is therefore easy to see why so many of these houses burst into flames immediately after the earthquake. It is said that fifty-seven fire alarms were sent to the Fire Department within the first half hour. Of course not all of these fires were produced by fallen or cracked chimneys in frame buildings. Some were similarly started in cheap brick structures, which are just as readily inflammable,—and still others by the breaking of electric wires of high tension, or through improper electric insulation of power wires.

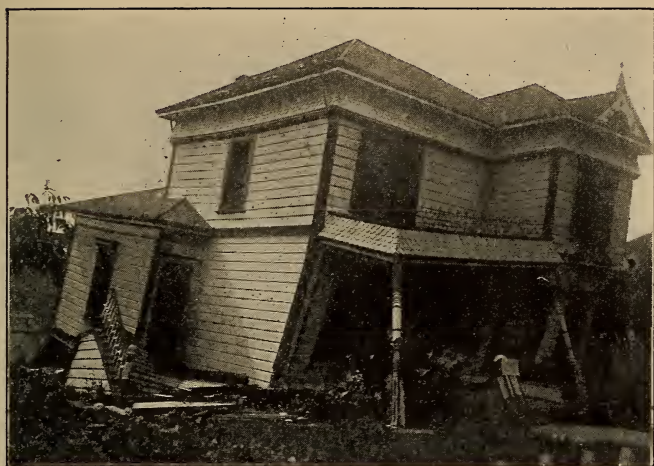
FIG. 15—Frame House Wrecked in Santa Rosa; Due to Weak and Decayed Underpinning.

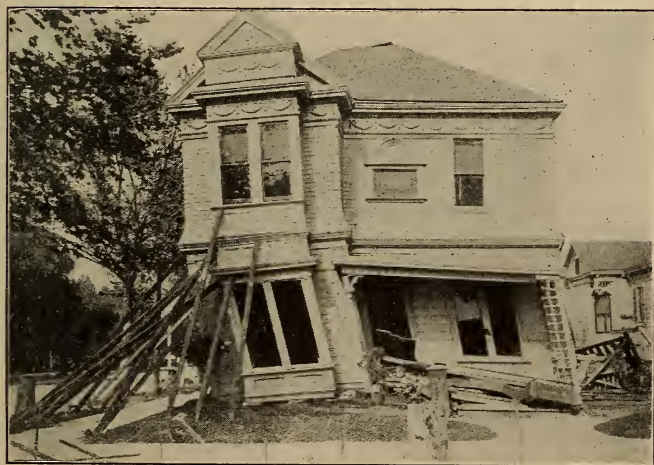
FIG. 16—Collapsed Frame House in San José Showing the Effect of a Lack of Transverse Framing and an Absence of Continuity in the Vertical Sticks at the Floor Levels.

shock and represent a most desirable type for small dwellings. The weak feature is the brick chimney. But even this can be built so that cracking will not be so complete as to cause fire. For earthquake countries wooden buildings should be intelligently framed to act like an elastic cage or unit, and the foundations should be carried below the surface sufficiently to reach firm ground. It is too common a practice which completes one story of a framed house before starting the frame for the next story. Where there is no continuity in the main wall framing from floor to floor, weakness exists at the floor level; consult Fig. 16.

Hotel Vendome, improperly framed and with weak underpinning, completely collapsed; see Fig. 16.

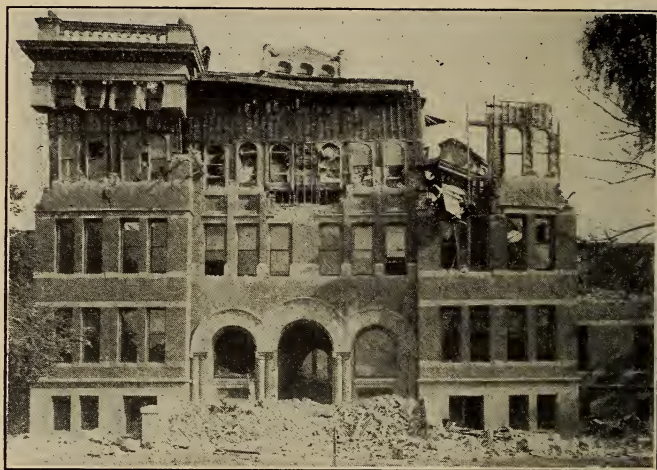
The prime requisite for a structure to withstand earthquake shock is elasticity; that is, the ability to return without serious damage to its original shape and position after being distorted. It should vibrate without offering great resistance to distortion; in other words, it should yield readily. The wooden framed and the steel framed building answer this requirement. To an almost equal extent the reinforced concrete building does so also. But structures of brick and stone built of blocks, like brick work and cut-stone masonry, with horizontal and vertical mortar joints do not answer the requirements of yielding and elasticity to any desirable degree. This is especially true when the interior framing is of wood and of the weak and faulty design depicted in the preceding paragraphs. Brick and stone walls when not sufficiently reinforced and intelligently strengthened and supported by steel framing are inadequate for import-

ant buildings in an earthquake country. Consult Fig. 17.

FIG. 17—*A San José High School. Ordinary Brick Construction with Wooden Interior.*

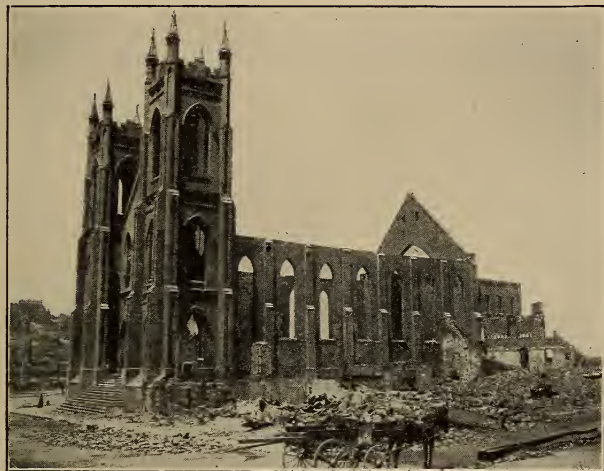
FIG. 18—*St. Francis Church, San Francisco; an Example of Excellent Brickwork.*

damage. I refer to several churches, see Fig. 18, to the Custom House or Appraiser's Building and to the Palace Hotel. The walls of the Appraiser's Building were thirty-six inches thick. The Palace Hotel was built immediately after the earthquake of 1868 and was intended to be earthquake-proof. The outer walls were most carefully designed, the window openings were crowned with arches and

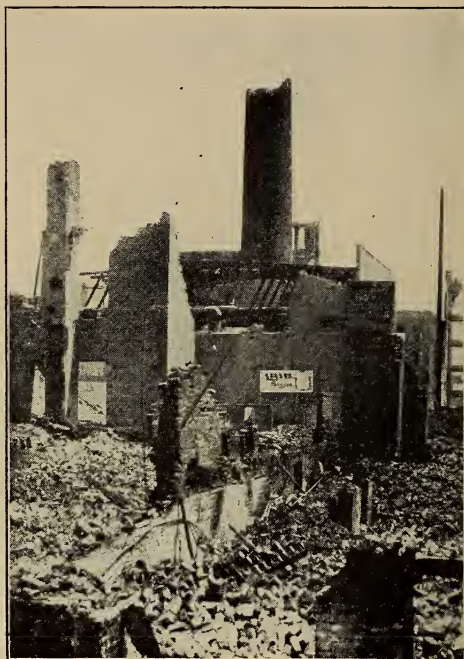
Chimneys in San Francisco were built of brick and very often without cement in the mortar. With few exceptions the chimneys were thrown down by rupture within the middle third of the height. A number of lives were lost by falling power house chimneys; see Fig. 20. In the future I believe chimneys should be built of reinforced concrete and not of brick. Where brick is insisted upon, the bond should be carefully provided for, the mortar should be rich in cement and there should be some metal reinforcement.

FIG. 20—Fire Ruins of a Power-House of the San Francisco Gas and Electric Company, Station C. The Chimney of This Structure Fell During the Earthquake Shock, Demolished a Part of the Equipment and Killed One Person.

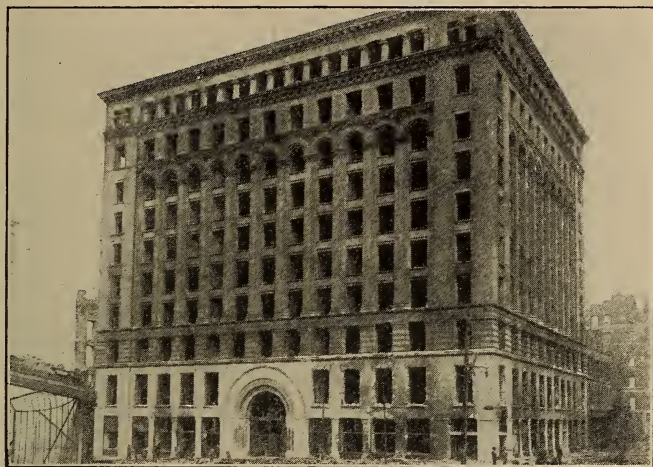
certainly should not advocate self-supporting walls for earthquake countries. The Mills Building in San Francisco, Fig. 21, an otherwise excellent structure of ten stories, was designed with self-sup-

FIG. 21—*The Mills Building, San Francisco; Self-Supporting Brick Walls, Interior Framing of Steel, Floors and Partitions of Hollow Tile.*

porting walls and with main columns breaking joints at every floor level. After the earthquake the walls of this structure leaned from seven to nine inches into Bush Street. While the structure did not appear to be severely racked by the earthquake, the fact that the walls bore little relation to the interior frame, and the interior frame lacked continuity of columns at every floor, would not lead

me to recommend such a type of structure for an earthquake country. Moreover, the type exhibits great weakness in resisting fire because the walls tend to leave the frame. In Class B buildings it was a general observation to note heavy cracks run-

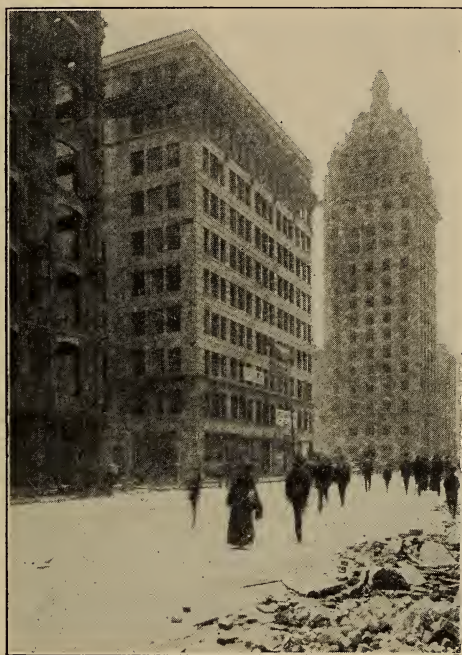
The earthquake vibration very generally produced X or so-called "earthquake cracks" in the outer curtain walls of Class A structures. It was very common to see brick work shattered between windows; and on large side walls, without window spaces, examination showed cracks running at angles of 45° to the horizon. Often heavy crack-

ing was observed at a corner of a building, see Fig. 23. Such destruction is not so serious in Class A buildings as in those designated Class B,

FIG. 23—*The Monadnock Building, Showing Heavy Diagonal Cracks in the Brick Curtain Walls along the Northeast Corner for the Full Height of the Structure.*

which have self-supporting walls, because it is a simple matter to restore the wall at any floor level of a Class A structure without disturbing the rest of the building. Much of the heavy cracking found

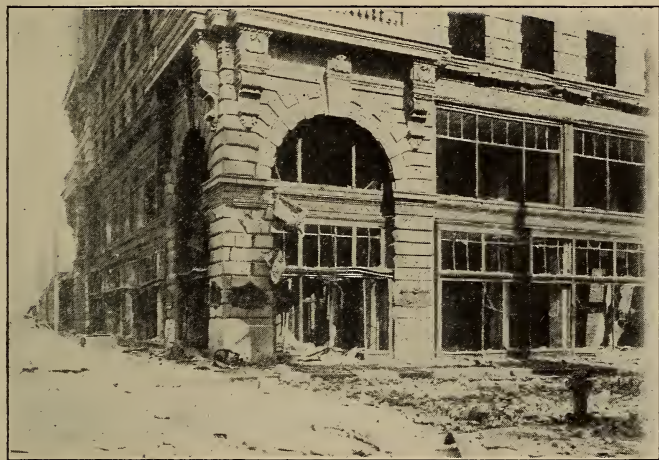
prominent cracks in the first story walls (Fig. 24), especially at points where heavy weights were concentrated upon corner columns. The stone work of corner columns was severely cracked where the masonry rested upon concrete under the sidewalk,

FIG. 24—*Flood Building, Northwest Corner, Showing Heavy Earthquake Cracking of the Sandstone Masonry Enveloping the Steel Corner Column.*

but hardly at all where the stone masonry was carried by the steel frame. Main columns acted like stilts to support the superstructure above the ceiling of the street floor, and prevented the collapse of many a building by column rigidity and continuity at the floor connections in the level of the second floor. It is plain that such floor connections

can not be too carefully designed. The most pronounced cracks at first-story columns were found in the Flood Building. One saw them also to good advantage on the sandstone front of the St. Francis Hotel (Fig. 25). Cracking of this character is not an evidence of weakness in the body of the building.

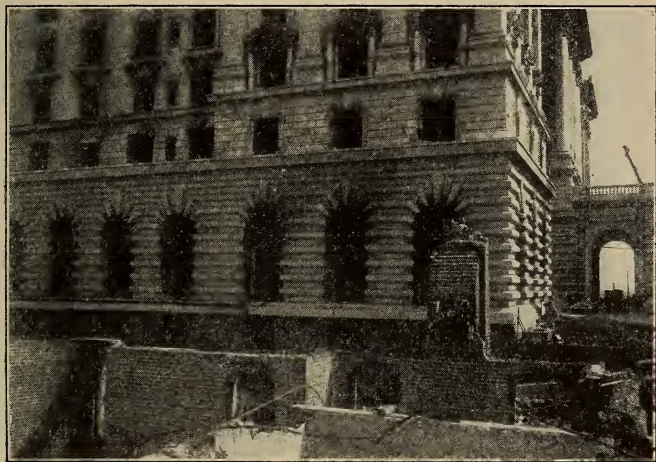
In Class A structures terra cotta was very generously and profusely used for ornamentation on the facing of the curtain walls of the street fronts. Being a material of the same nature as hollow tile, it is brittle and lacks toughness. It was generously spalled by earthquake vibration, and, while I by no means wish to imply that its use should be prohibited, I think it should be very carefully selected, be well burned, be used with greater thickness than in the past, and the hollows in the blocks should be filled. Highly ornamented terra cotta should be discouraged. The earthquake produced considerable spalling in the terra cotta of the Mills Building, and very generally damaged the terra cotta face of the Fairmont Hotel, especially on the north front (Fig. 26).

FIG. 26—Fairmont Hotel; North Front, Showing Earthquake Cracks in the Terra-Cotta Veneer of the Second Story Walls.

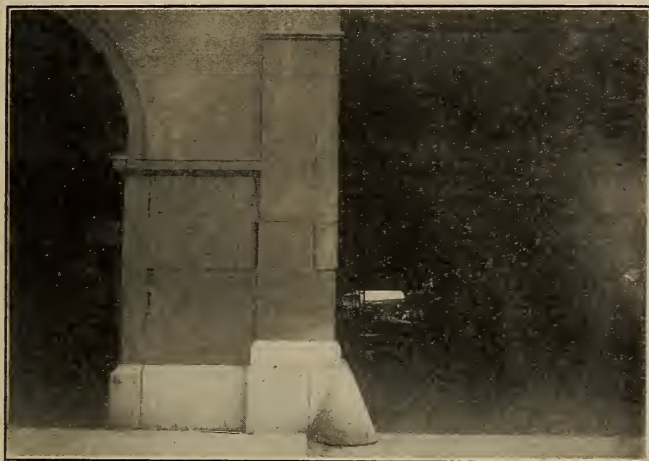
FIG. 28—Earthquake Cracks on Sandstone Piers of the Ferry Building. These Piers Enclose Steel Columns with a Complete Air Space between the Steel Columns and the Stone Blocks. This Explains the Large Amount of Cracking and Shows That the Stone Piers Are Not Required for the Support of the Second Story.

bear against the structure from the land side, tending to thrust it into the bay. The building rests on piles in large clusters, and withstood its severe test admirably. The top of the south end wall fell out. The stone work near the street level on the main pilasters was badly cracked (Fig. 28). In the second story horizontal joints were opened throughout the west front length of the building. The marble plates on the interior walls were much broken. The tower was shaken like a tree or flag-pole in a vertical plane east and west, nearly coincident with Market Street's length. The east and west faces of the tower were therefore badly racked, just above the roof of the main building, and the stone facing at these places was thrown down, causing considerable destruction in the interior in the central portion of the building below the tower, see Fig. 29. The upper portion of the tower was originally designed in stone, but the consulting engineers advised the substitution of metal sheeting to reduce the weight, and this fortunately was done. Had the upper portion of the tower been of stone, I believe the destruction would have been very much more serious. The stone facing of the tower was backed with brick, and this masonry was supported by a steel frame, as in Class A buildings. It appears that the steel frame was built too light, especially the diagonal members. These

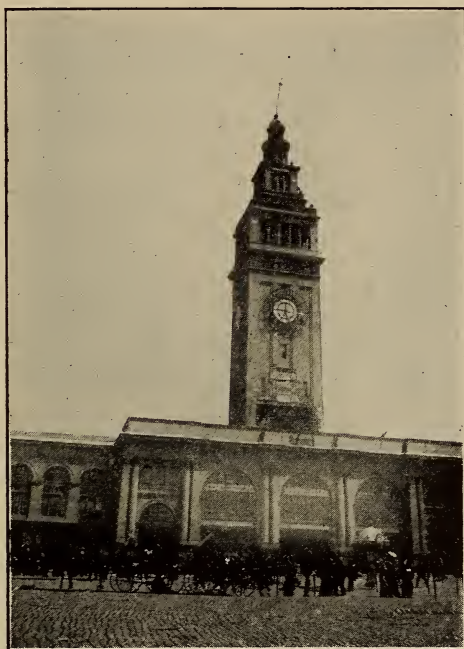
diagonals should have been heavier, and of stiff sections instead of rods. Some of the diagonal rods were snapped and some gusset plate connec-

FIG. 29—*The Ferry Tower Shortly after the Earthquake.*

tions and riveted joints were ruptured. I have already referred to the superior merit of quadri-lateral framing, using spandrel girders and knee bracing. The tower was rapidly dismantled, the

steel frame strengthened and repaired and re-clothed with reinforced concrete curtain walls.

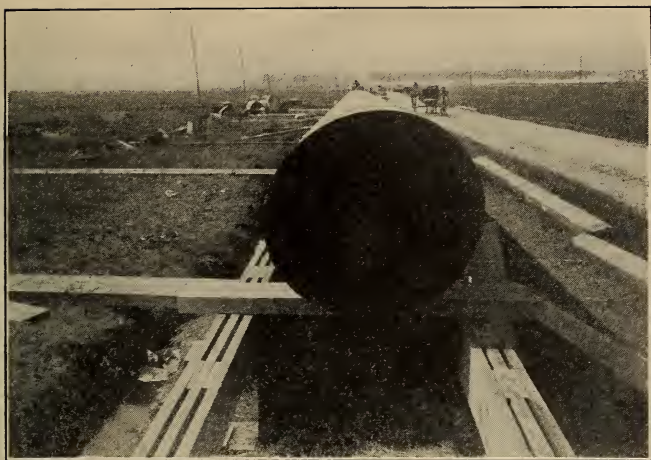
FIG. 32—Rupture on Crystal Springs Pipe Line, San Bruno Marsh.

exhibits a view of one of the ruptures on the San Bruno marsh. Figs. 32 and 33 show other scenes along this pipe line during the period of repair immediately following the earthquake. Redwood planks were used for the temporary sills and stringers because larger timber was not quickly available.

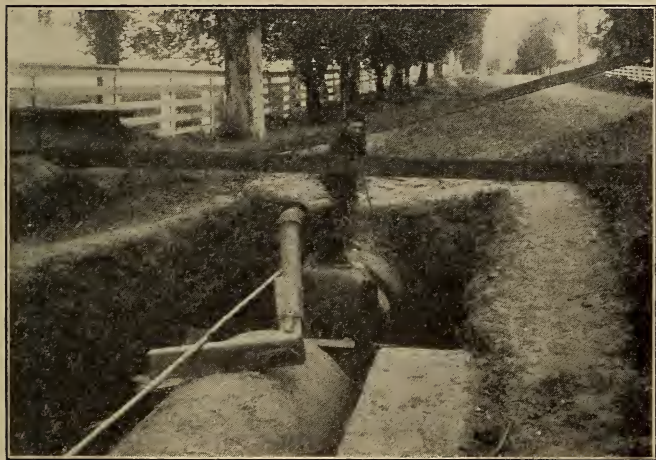
FIG. 33—Crystal Springs Conduit between San Mateo and Millbrae. Temporary Cut-Off to Stop the Flow of Water toward San Francisco and Yet Maintain a Pressure and Supply for the City of San Mateo.

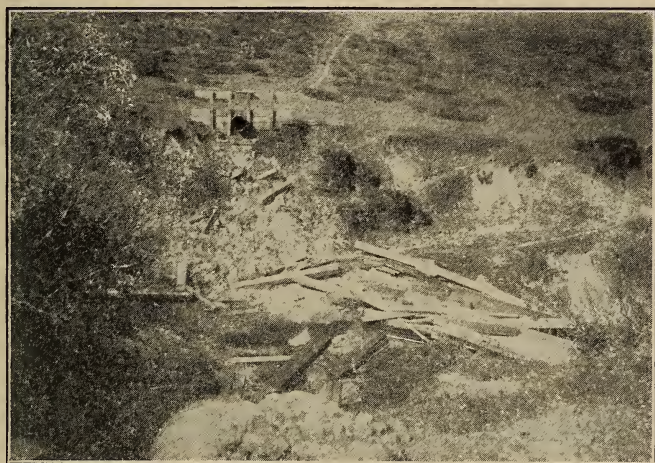
FIG. 35—*Collapsed Trestle at Frawley Gulch, Pilarcitos Pipe Line, Spring Valley Water Company.*

about 100 feet in length and some 25 feet in maximum height. Some of the timbers of this trestle were partly decayed, but the structure certainly was not weak. This trestle was about $\frac{1}{4}$ mile to the east of the fault line. Nevertheless the shock was so severe that it entirely demolished the trestle and pipe which it carried. The trestle probably vibrated in a vertical plane normal to its length,

and was thrown down-stream to the southeast, as shown in Fig. 35.

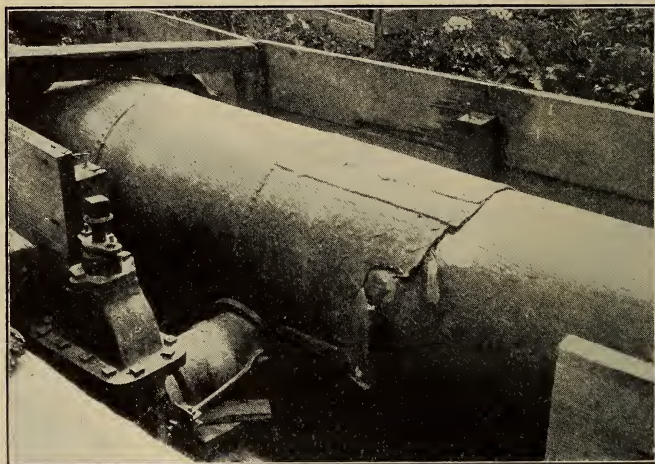
FIG. 36—*Telescoped Rupture, Pilarcitos Pipe Line, Spring Valley Water Company.*

Figs. 36, 37, 38 and 39 show additional ruptures in the Pilarcitos pipe line between San Andreas Lake and Frawley gulch. In Fig. 36 the pipe line,

supported on a timber framing, crosses a small swale. The pipe was telescoped 41 inches, and the blow-off valve connection was partly ripped from the conduit. Fig. 37 shows two ruptures a little

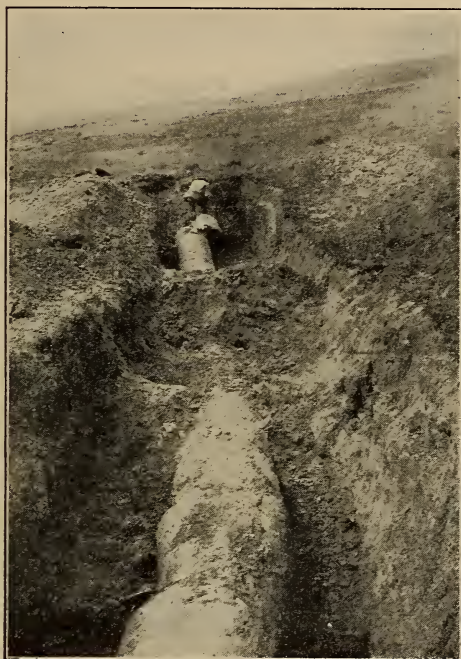
FIG. 37—*Diagonal Ruptures, Pilarcitos Pipe Line, Spring Valley Water Company.*

to the north of the break in Fig. 36. At the point where the man is standing the fault line crosses the pipe line at an angle of 45° . The pipe was sheared so that its parts are 20 inches out of alignment, and are moved toward each other 40 inches.

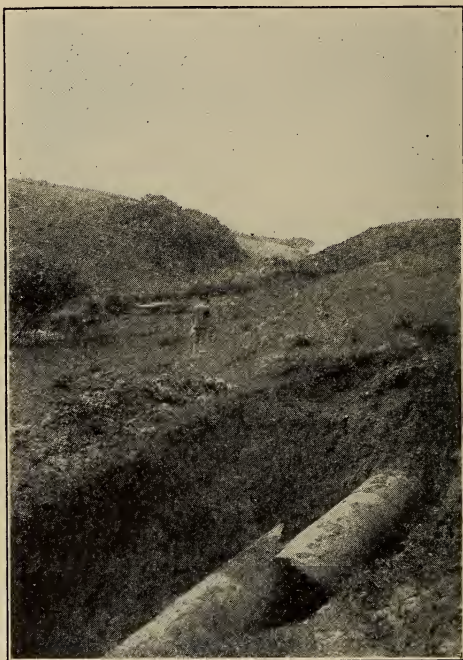
FIG. 38—*Diagonal Rupture, Pilarcitos Pipe Line, Spring Valley Water Company.*

Fig. 38 is a closer view of the same rupture. Fig. 39 shows the pipe crossing a small gulch. The blow-off valve situated at this point was stripped from the pipe and thrown ten feet. The pipe was telescoped 49 inches and thrown out of alignment, as shown. This rupture strikingly shows that the pipe metal was of high quality.

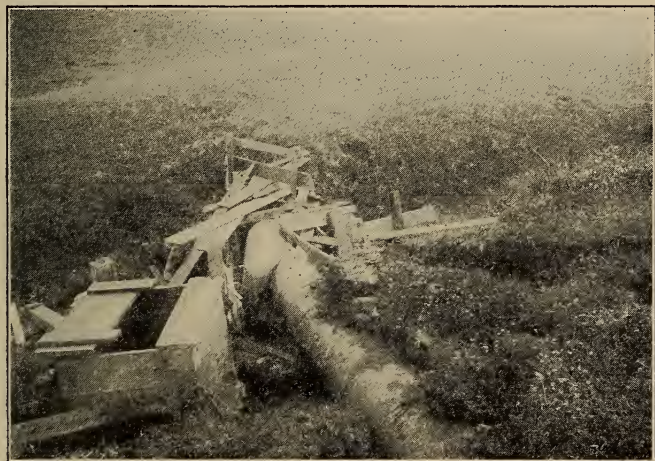
FIG. 39—Collapse by Compression at a Small Trestle, Pilarcitos Pipe Line, Spring Valley Water Company.

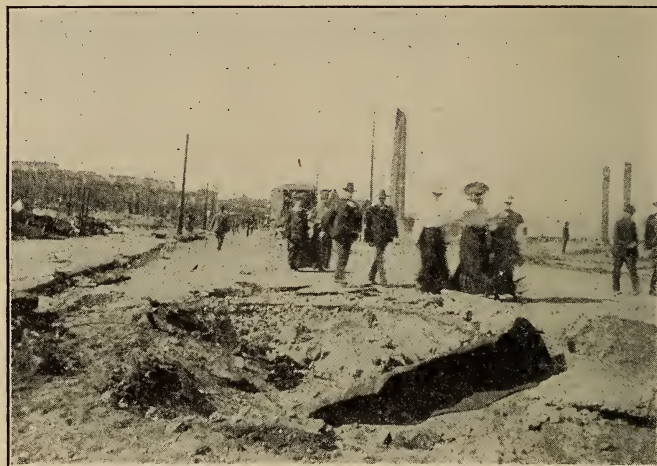
FIG. 40—*Gas Main Explosion, Valencia Street, near Market Street, San Francisco.*

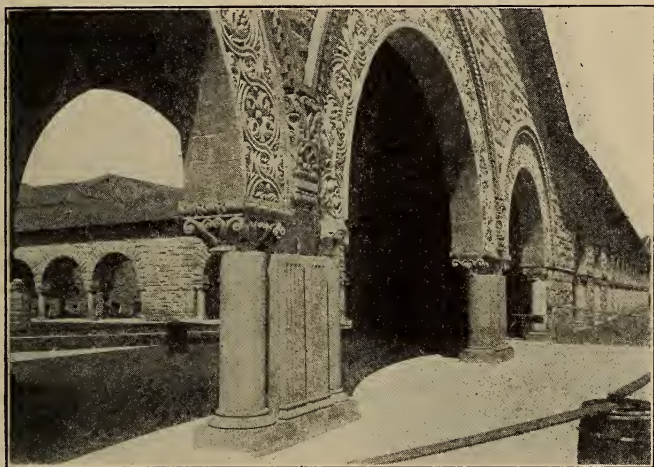
FIG. 41—Arcade, Inner Quadrangle, Stanford University.

tion. I consider the third reason by far the most important. Heavy stone-faced buildings of the type we find at Stanford, no matter how well built, cannot resist an earthquake of the intensity experienced at Palo Alto, when we consider the nature of the ground upon which the buildings rest. Top-heavy stone arcades and walls, supported by light masonry pillars, see Fig. 41, are not constituted to

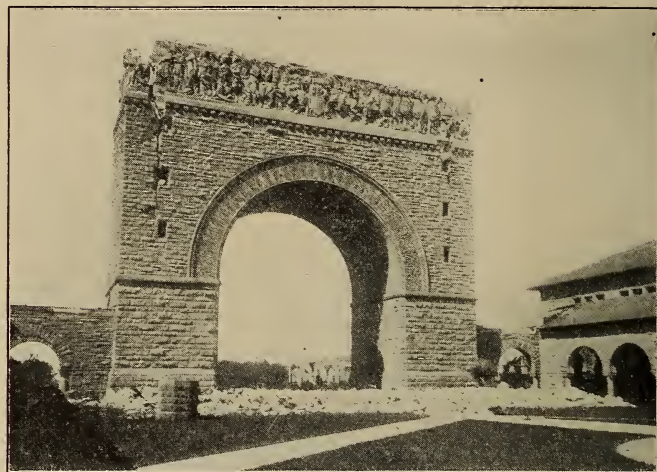
FIG. 42—Rear View Memorial Arch, Stanford University, Showing Arch Ring Intact.

I have seen many pictures of the Memorial Arch showing dramatic destruction. These pictures give a false impression. Fig. 42, a view of the rear elevation, shows that the arch ring itself was not thrown down; in fact, there were but a few cracks in the crown of the soffit. It was the heavy top and cornice, insufficiently tied, that fell, as they should. It would have been surprising had they not fallen. Above the arch was a large box-shaped mass of masonry upon which rested the heavy overhanging cornice, and this box had practically no transverse framing or partition walls of any kind. The masses that dropped from the arch fell in large pieces, nearly 100 feet to the pavement without crumbling, Fig. 43, which proves that the mortar was good. Considerable cement was used in the mortar for the

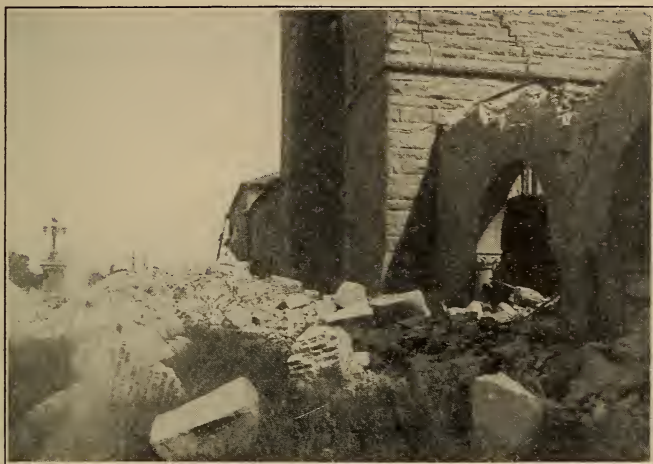
FIG. 43—*Fallen Masonry from Top of Memorial Arch, Stanford University, Showing Mortar Strength.*

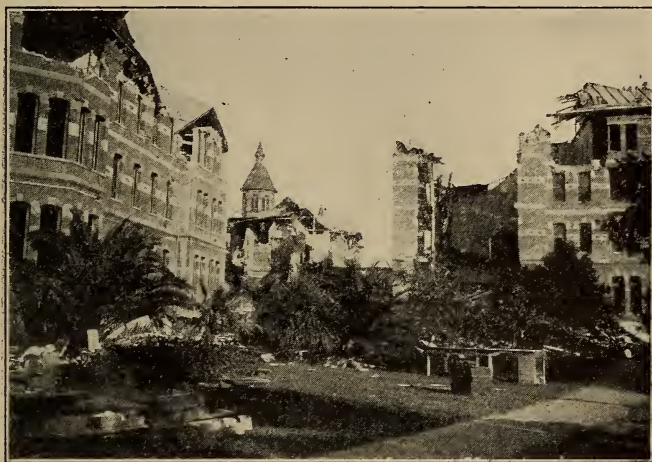
FIG. 44—View at Agnews Showing the Complete Collapse of the Main Tower of the Asylum.

seriously to realize the situation? The main central brick structure and tower of Agnews Asylum, Fig. 44, entirely collapsed. The central tower fell en masse and crumbled to pieces so that three distinct wings of the buildings, themselves much demolished, were left disconnected. Some of the outer, smaller buildings had nine-inch brick walls

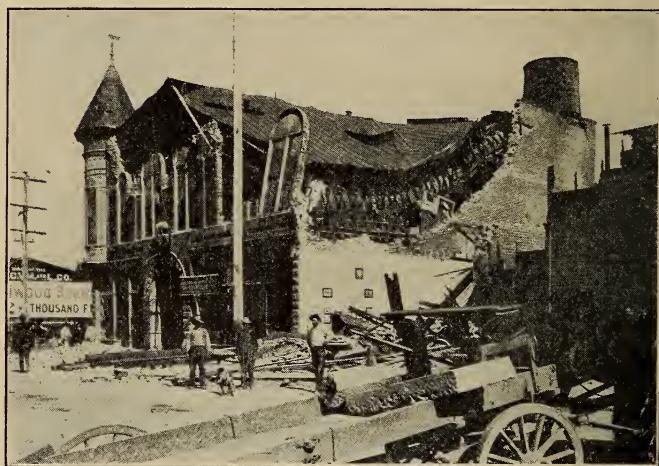
FIG. 45—*Earthquake Destruction, Native Sons' Hall, San José.*

San José, about forty miles to the south and east of San Francisco, is thirteen miles to the east of the fault line. This city fortunately was spared a conflagration. The earthquake destruction was appalling, as is shown by a few typical photographs; see Figs. 45, 46, 47, and 48.

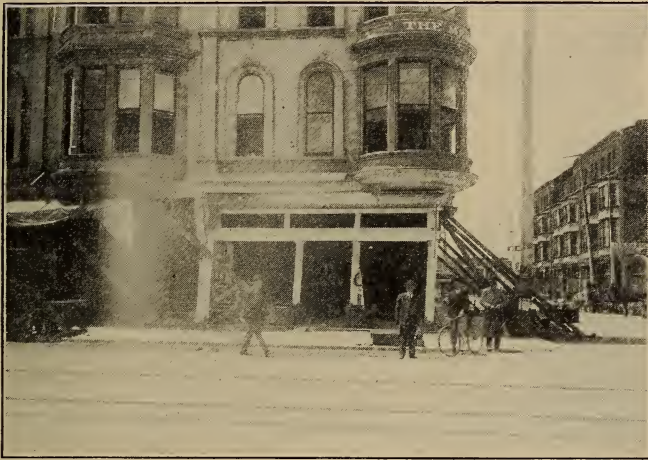
FIG. 46—A View on First Street, San José, Showing Lack of Framing for First Floor. These Buildings Were Later Pushed Back into Place.

occupied these main floors, demanding large window openings and as much floor space as possible. Virtually the upper portions of the buildings rested on stilts; see Fig. 46. Public buildings in San José, with the exception of the postoffice, were

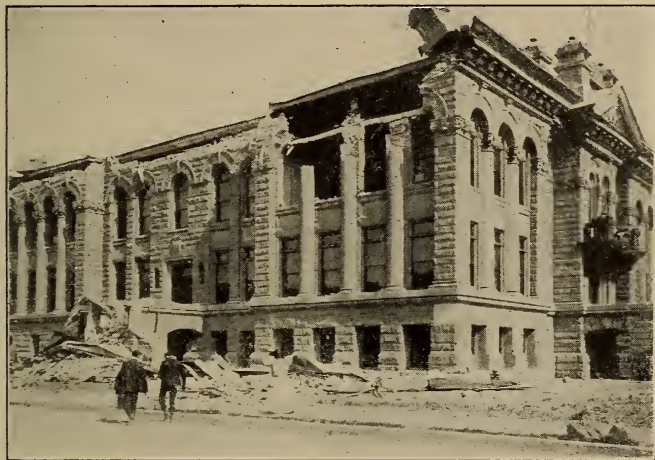
FIG. 47—*Hall of Justice, San José, Completed in 1905.*
